# **Water Safety Inspection and Risk Assessment Report of Boughton Village Green and Pond**

**By Kevin Fisher (NEBOSH)  
For Boughton Parish Council**

## WATER SAFETY SITE ASSESSMENT

**Site Location: Boughton Village Green and Pond**

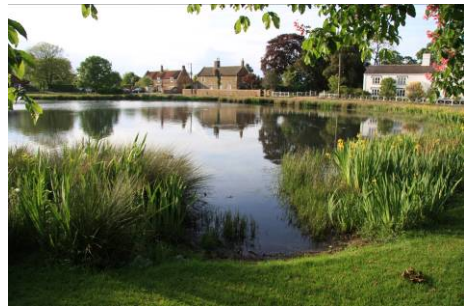
West side of pond showing gently sloping access/egress

**R1** - To discourage/prevent persons approaching and accidentally entering or falling into the pond it is recommended that the existing natural barrier of wetland flora and fauna should be maintained and not removed. Additional planting of similar wetland shrubs should be made to where the known deep areas of the pond are located. This planting whilst being fitting to the area will also act as a natural obstacle and discourage persons getting too close to the waters edge. Some areas should be left clear to allow egress from the pond should someone accidentally fall in.

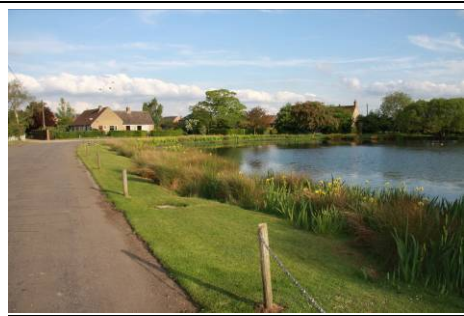
North side of pond showing the area of non-continuous chain link fencing. Pond edges predominantly delineated with flag irises and reeds

**R2** - The use of a continuous fence around this pond area is an option, but would not stop children gaining access to the pond should they want to. However, it is still recommended that efforts should be made to continue the existing chain link fencing to provide a first line obstacle.

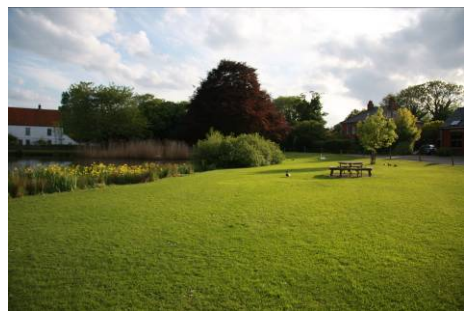
East side of pond showing 'picnic'/seating area

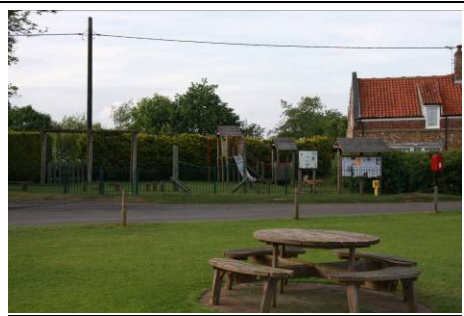
East side of pond showing adjacent self-contained recreation area

It is anticipated that it is unlikely, due to the location of the adjacent recreation area, that young children (toddlers) will enter the area unsupervised. Older children (5 - 12) will use the recreation area to play and therefore a clear natural boundary as detailed above would further discourage them getting too close to the water. Younger children feeding the water fowl are likely to be supervised.

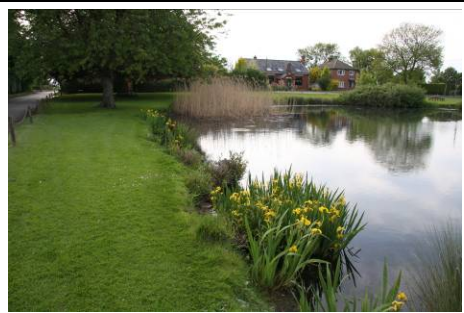
South side of pond where deepest water is advised to be. Side is adjacent to main thoroughfare of village

**R4** - A precautionary notice, or notices, should be erected to warn of deep water danger and the need for adult supervision of children, also consider winter signage such as 'Danger – Thin Ice'
